BOLIGBRANN

REPORT NO./DNV REG No.: / 13XKQRR-1  
REV , 2012-01-05

Summary:  
 This report covers testing of a hose to be used in case of house fire. The hose was supplied by Gowens engros.

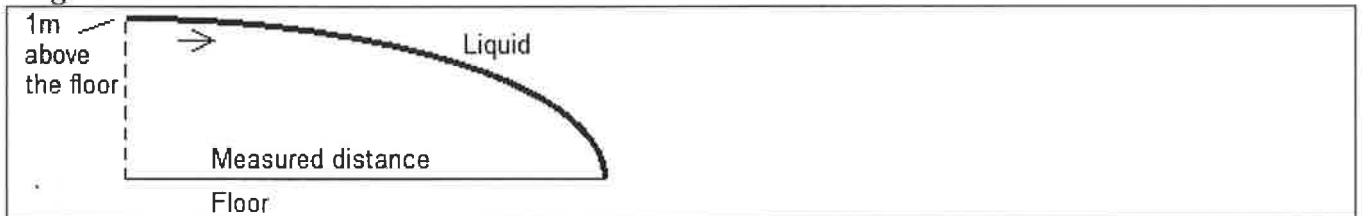
**Figure 3-1:** Measured distance from hose outlet. The hose outlet was 1m above the floor.

The “length of thrust” test included measuring the length from the hose outlet to hitting the floor. The hose was held as normal when standing trying to reach a goal as far away as possible. The test was performed with six 90 degree bends.

The result was a “length of thrust” of approximately 7m. This was regarded as sufficient for the use of the hose.

Test01. Length of thrust.  
Upstream pressure 1.4 bara.  
Distance 6.8m.

Test03. Length of thrust.  
Upstream pressure 1.2 bara.  
Distance 6.8m.

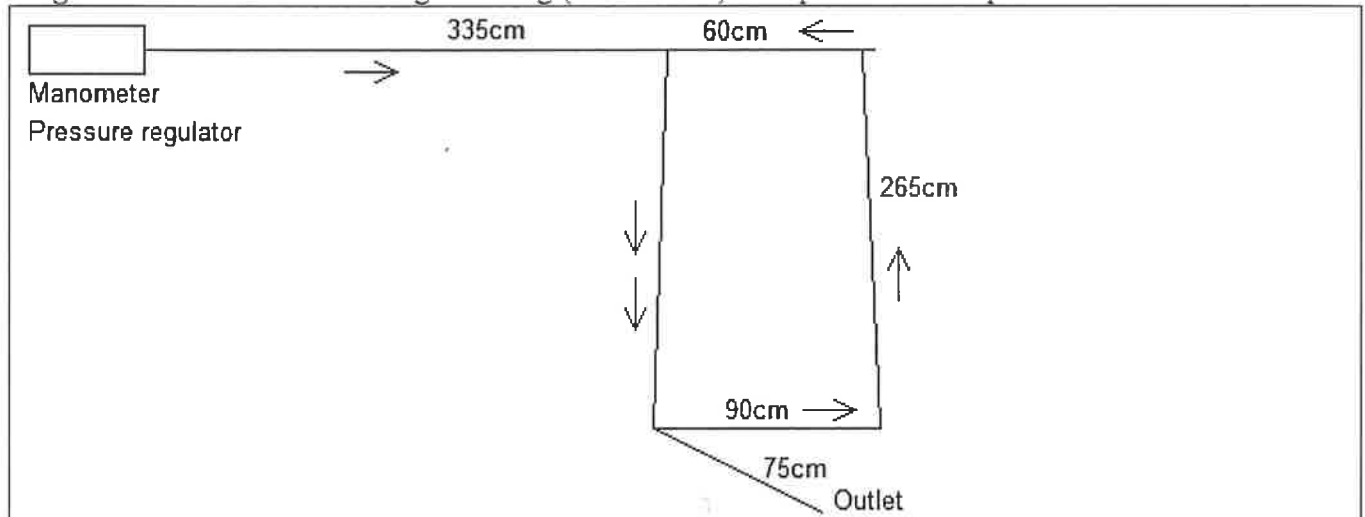
**Figure 3-2:** Schematic drawing of testrig (from above). See pictures in chapter 5.

The tests should be performed when the hose had six 90 degree “bends”. The bends should be of a type that would normally occur. That means not too twisted and not too little.

The water system in the house gave 5 bara. Thus, a pressure regulator was used to take it down to approximately 2 bara. Before the pressure regulator, there was a valve to control the flow volume. After the pressure regulator, there was a manometer to record pressure.

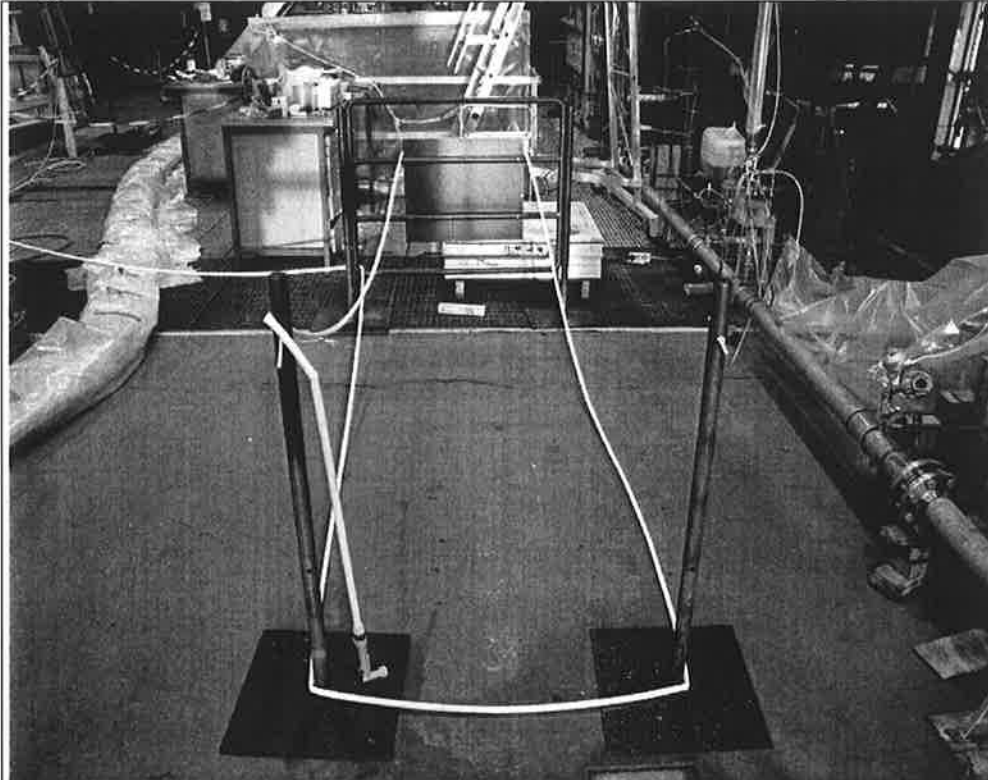
**Figure 6-1:** The hose with six bends.

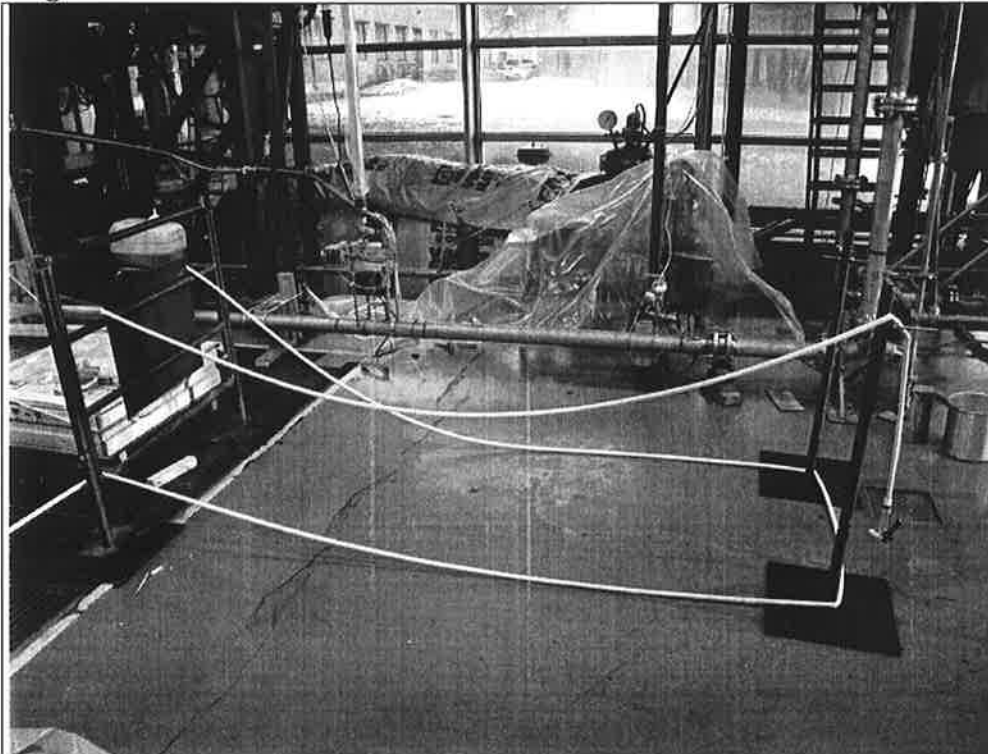
**Figure 6-2:** The hose with six bends. Side view.

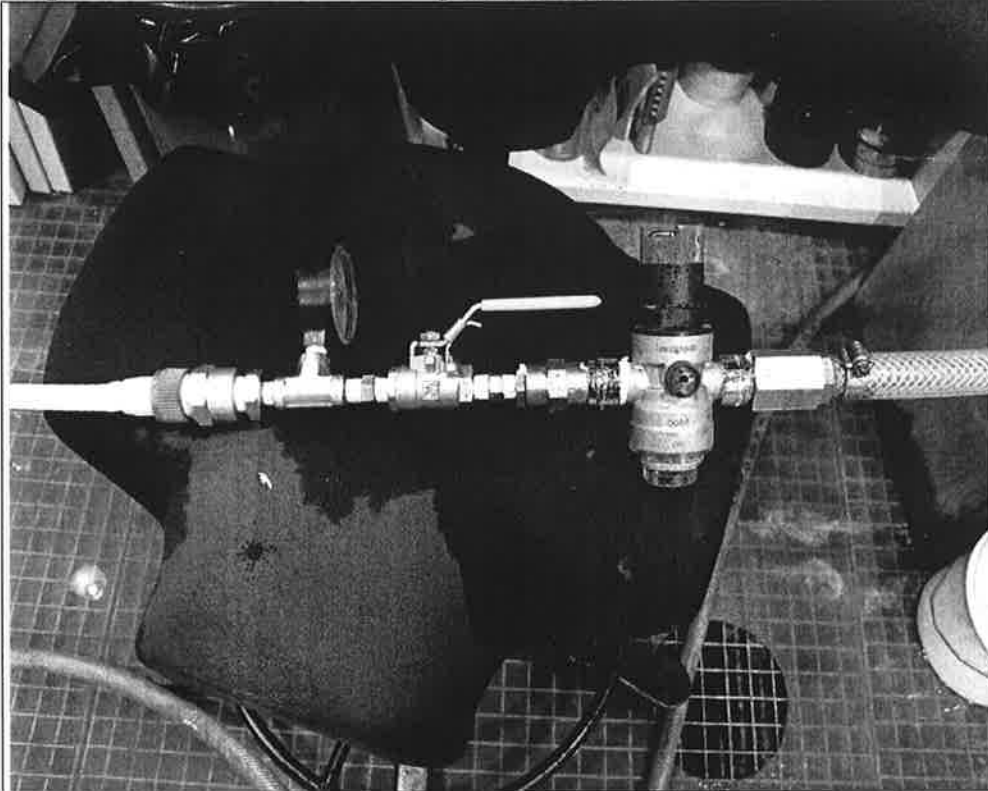
**Figure 6-3:** The manometer and pressure regulator.

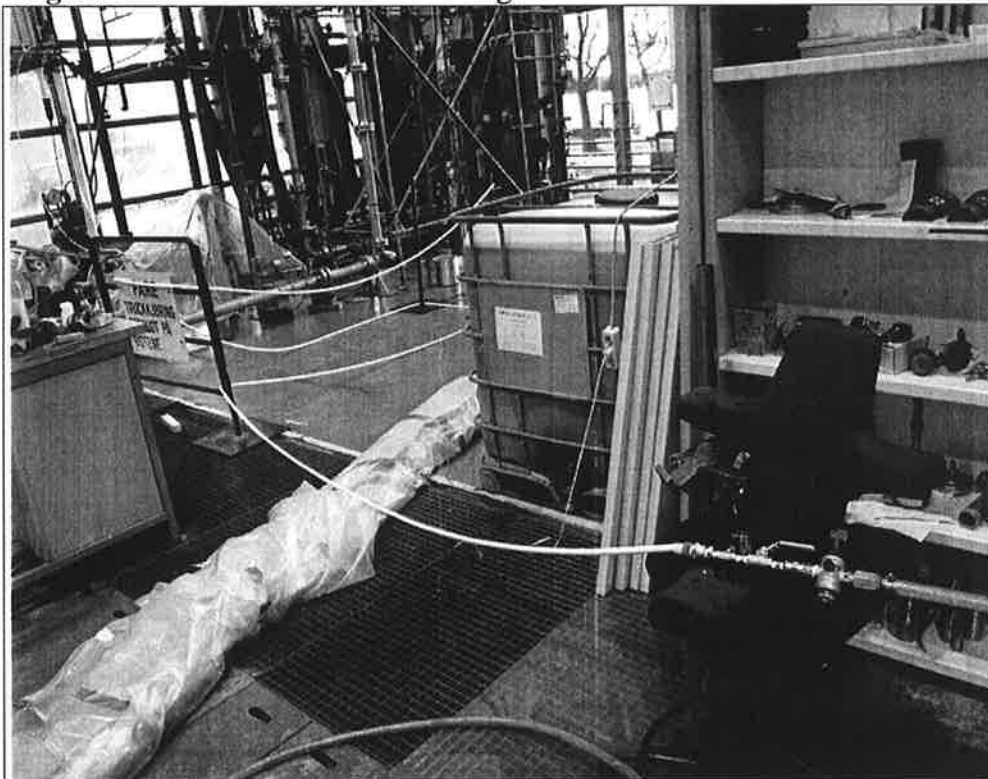
**Figure 6-4:** The hose above the testrig.

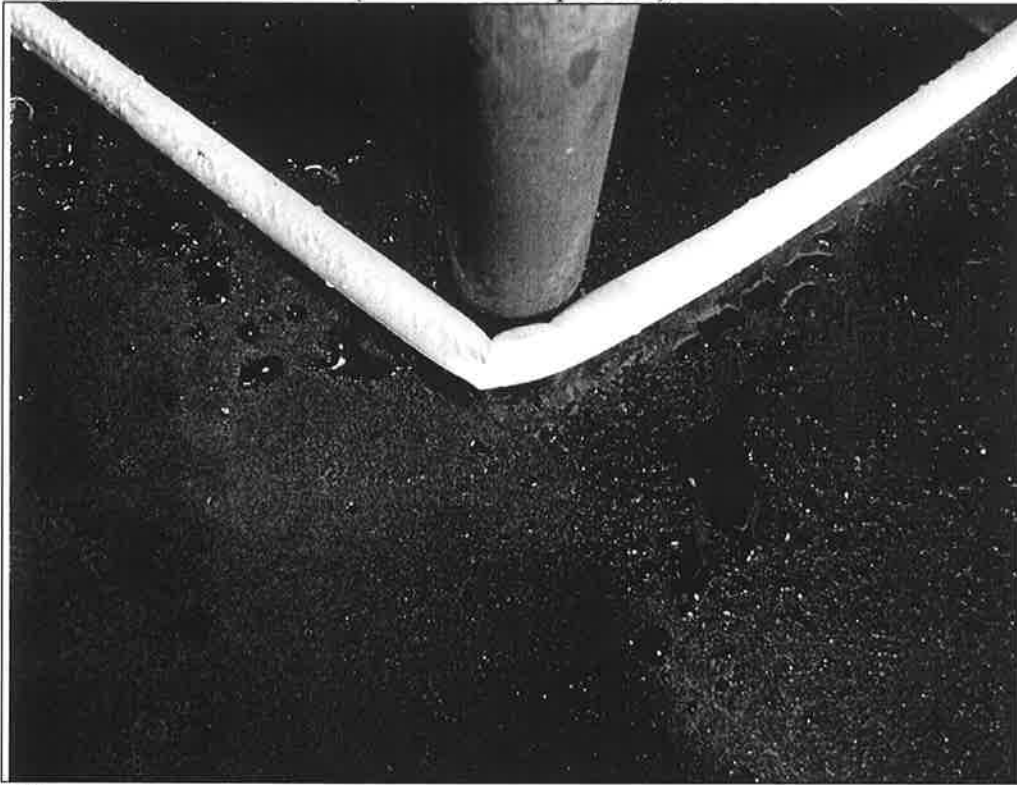
**Figure 6-5:** Second bend (counted from upstream).

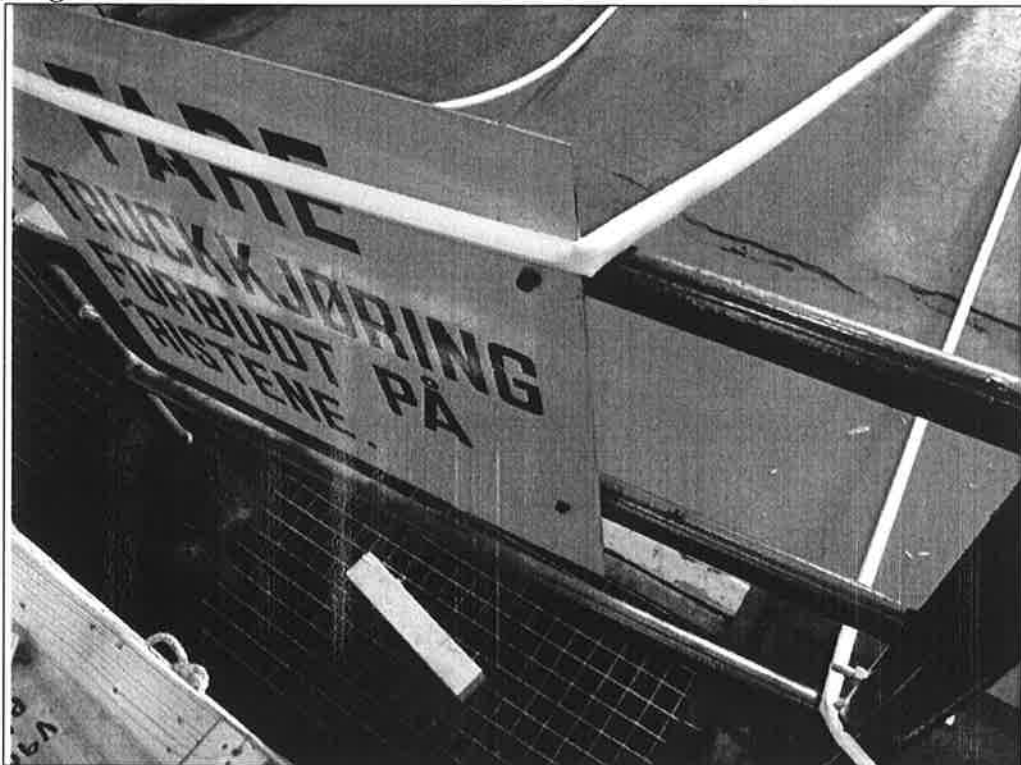
**Figure 6-6:** 1:st and 5:th bend.

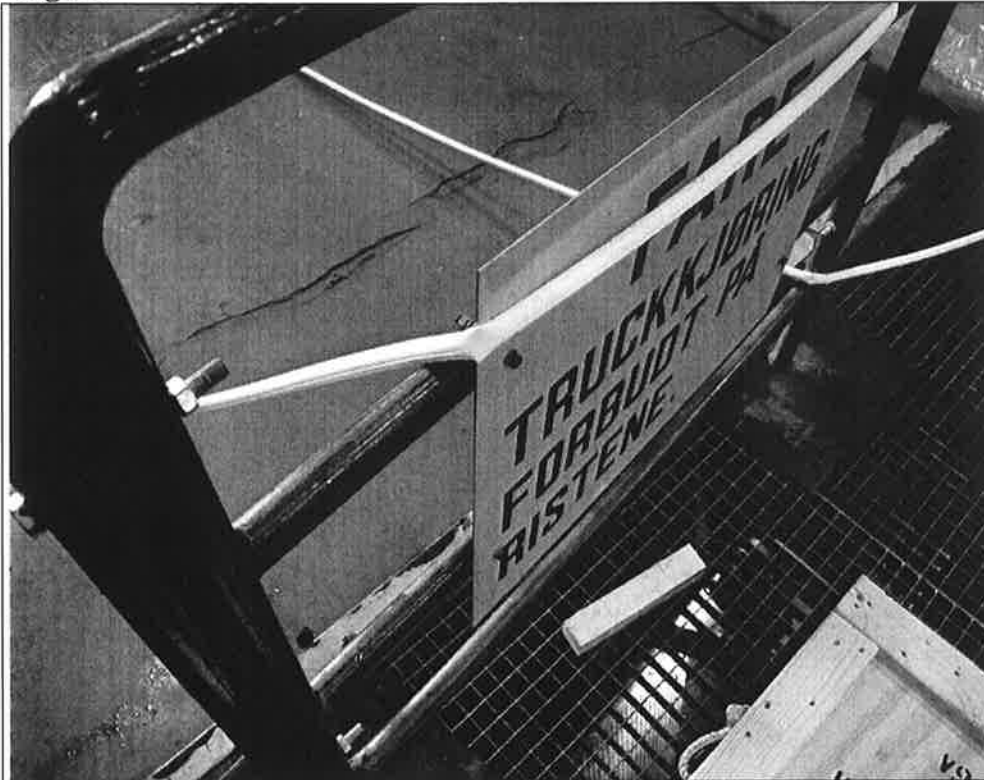
Figure 6-7: 4:th bend.

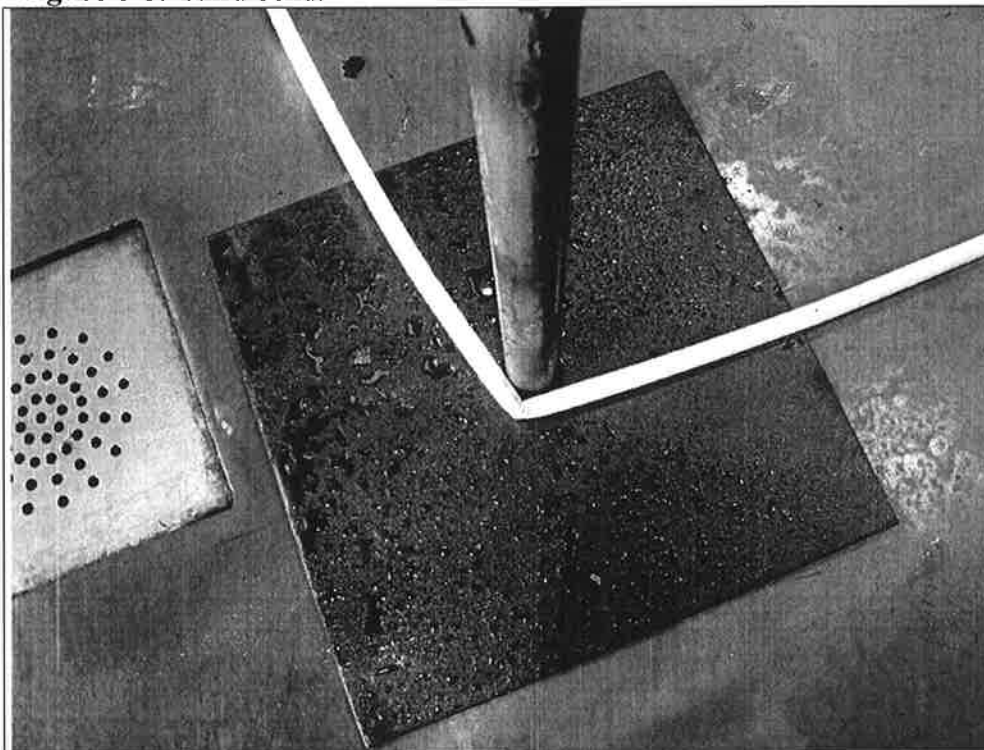
Figure 6-8: Third bend.
